FIRE AND EXPLOSION GROUP FACTUAL REPORT

DCA-96-MA-070

Location : East Moriches, New York

Aircraft : Boeing 747-131, N93119,

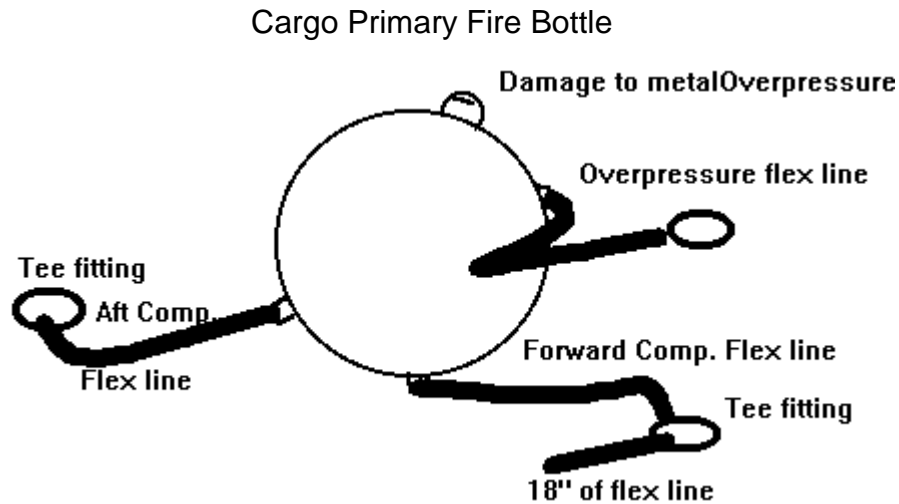
The bottle was found empty. The flex lines for the forward compartment, aft compartment, and overpressure discharge were attached. All lines were broken after the Tee fittings attached to the flex lines. The squib for the aft compartment had ~12" of the ground wire attached and ~1/2 inch of wire from the electrical plug. The squib for the forward compartment had no wire attached. There was a large (2 to 3 inch) tear in the metal dimple attached to the bottle. Other than a few dents, the bottle seemed to be free of any other damage.

The squibs were removed and inspected. They were intact and had not been fired. The frangible disks were intact and sealed to the discharge ports.
